Contract #: 04-0120F4Cty: SF/ALA Rte: 80 PM: 13.2/13.9File #: 69.28**WELDING INSPECTION REPORT****Resident Engineer:** Siegenthaler, Peter**Address:** 333 Burma Road**City:** Oakland, CA 94607**Report No:** WIR-017419**Date Inspected:** 13-Oct-2010**Project Name:** SAS Superstructure**OSM Arrival Time:** 700**Prime Contractor:** American Bridge/Fluor Enterprises, a JV**OSM Departure Time:** 1900**Contractor:** Zhenhua Port Machinery Company, Ltd (ZPMC), Changxing Island **Location:** Shanghai, China**CWI Name:** Li Yang**CWI Present:** Yes No**Inspected CWI report:** Yes No N/A**Rod Oven in Use:** Yes No N/A**Electrode to specification:** Yes No N/A**Weld Procedures Followed:** Yes No N/A**Qualified Welders:** Yes No N/A**Verified Joint Fit-up:** Yes No N/A**Approved Drawings:** Yes No N/A**Approved WPS:** Yes No N/A**Delayed / Cancelled:** Yes No N/A**Bridge No:** 34-0006**Component:** OBG Segments**Summary of Items Observed:**

On this date Caltrans OSM Quality Assurance (QA) Inspector, Dan Hernandez was present during the times noted above to observe the fit up, welding and related activities associated with the fabrication of the San Francisco Oakland Bay Self Anchored Suspensi

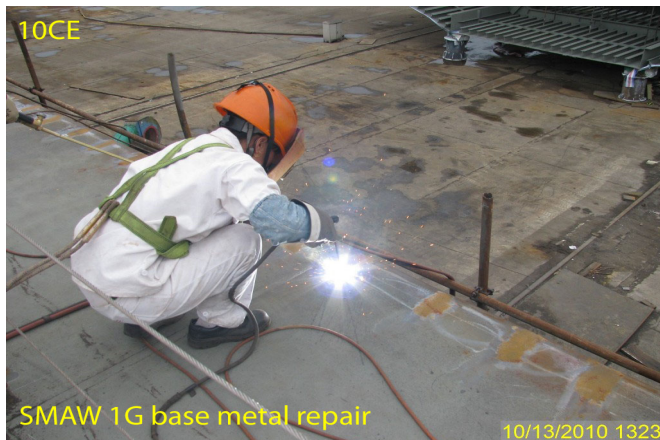
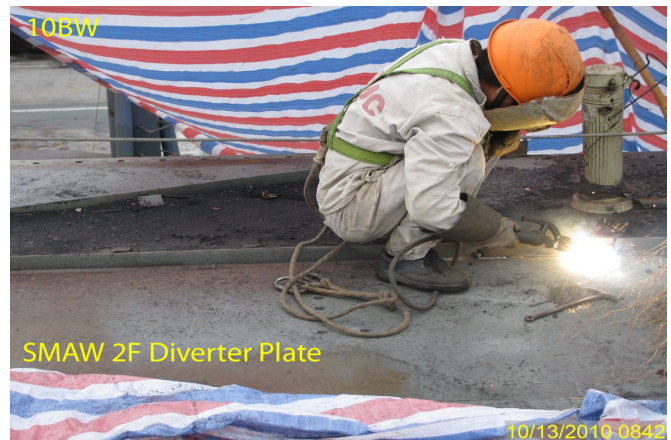
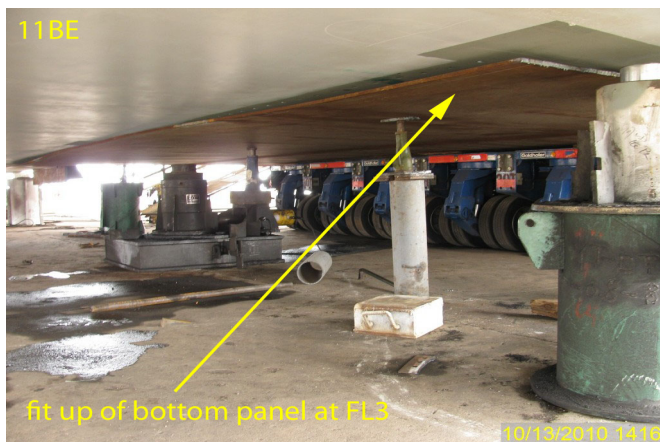
This QA Inspector observed Shielded Metal Arc Welding (SMAW) in progress of a fillet weld joint. The Weld joint is designated as OBW10E-003, 004, Diverter Plate. The welder is identified as #041713 and was observed welding in the 2F (horizontal) position using approved Welding Procedure Specification WPS-B-P-2112.

This QA Inspector observed Shielded Metal Arc Welding (SMAW) in progress of a Complete Joint Penetration (CJP) weld joint. The Weld joint is designated as OBW10E-035, 032, Diverter Plate. The welder is identified as #041713 and was observed welding in the 3G (vertical) position using approved Welding Procedure Specification WPS-B-P-2213-B-U2-FCM-1.

This QA Inspector observed Shielded Metal Arc Welding (SMAW) in progress of a Partial Joint Penetration (PJP) weld joint. The Weld joint is designated as RETRO-B3-10BE-044, Retro Plate. The welder is identified as #040581 and was observed welding in the 3G (vertical) position using approved Welding Procedure Specification WPS-B-P-2313-TC-P5.

This QA Inspector observed Shielded Metal Arc Welding (SMAW) in progress of a fillet weld joint. The Weld joint is designated as EP156-001-014, 12, Edge Plate I-rib hold back welds. The welder is identified as #040270 and was observed welding in the 4F (overhead) position using approved Welding Procedure Specification WPS-B-P-2114-FCM-1.

This QA Inspector observed Base Metal Repair using the Shielded Metal Arc Welding (SMAW) process at locations of removed fit up plates along the exterior of the Deck Plate transverse CJP splice. The welder is identified as #040484 and was observed welding in the 1G (flat) position using approved Welding Procedure Specification WPS-345-SMAW-1G (1F)-FCM-repair-1 for CWR1799.
